Trail Repair & Trail Bridge Reconstruction

– Recovery Act Projects –

Archuleta, Dolores, Montezuma, La Plata Counties

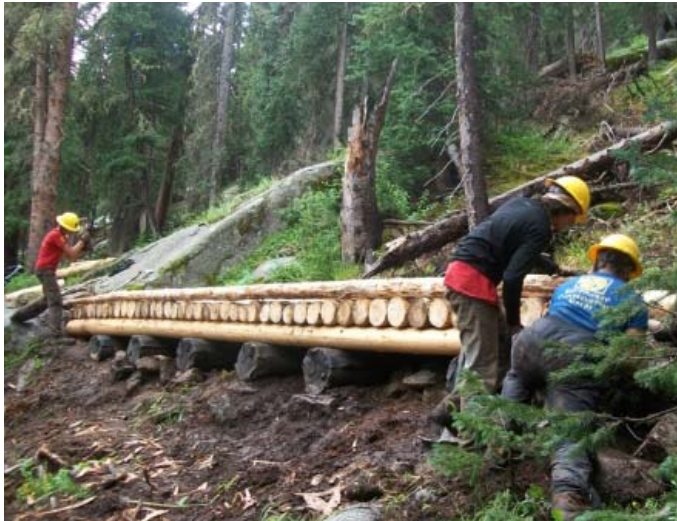
One of the most difficult projects was the reconstruction of a section of the remote Rincon La Osa Trail in the heart of the Weminuche Wilderness, Colorado's largest Congressionally designated Wilderness area.

Horseback riders and pack strings had had to use an old corduroy trail and bridge-type structure to cross a steep granite side slope seeking access to the upper Pine River drainage and Continental Divide. The Recovery Act funded the reconstruction of this degraded structure, which was dangerous to stock travel.

Because Rincon La Osa is within Wilderness, all aspects of the project had to be accomplished by primitive means. After the old structure was removed, trees were felled and stripped by hand. Large rocks were moved by hand, and yards of soil were carried to the site by crews and stock animals. The structure was contoured to reduce the grade and enlarge the crib steps, which are anchored into the granite slab via rebar and hand-drilled holes.

The result is a new structure that offers a safe crossing over 100 feet of the steep rock slope.

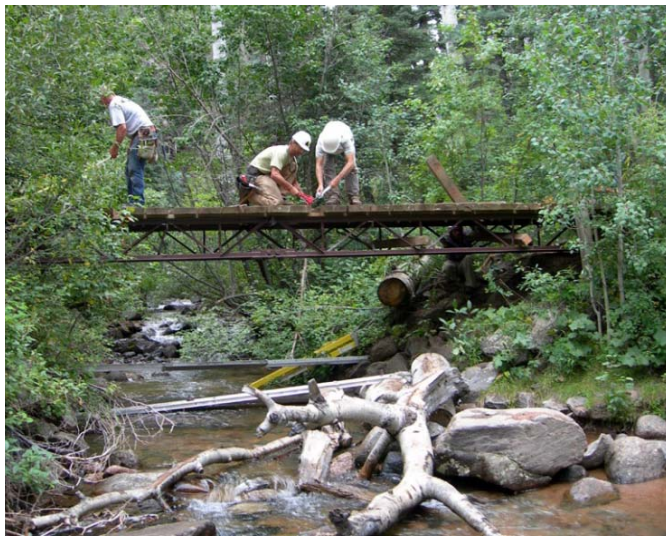
Seventeen trail bridges are being reconstructed and repaired across the San Juan National Forest, thanks to Recovery Act funding. Some projects involved extensive work; others were more minor in scope. The Lake Creek Bridge, offering access to Emerald Lake, had to be repaired via primitive methods because it is in the Weminuche Wilderness. Supplies were brought in by pack animals, and construction accomplished with hand tools. The bridge's deck structure was replaced, its steel superstructure painted, and approach rails installed.
